NBS BUILDING SCIENCE SERIES 143

Investigation of the Kansas City Hyatt Regency Walkways Collapse

DEPARTMENT OF COMMERCE • NATIONAL BUREAU OF STANDARDS

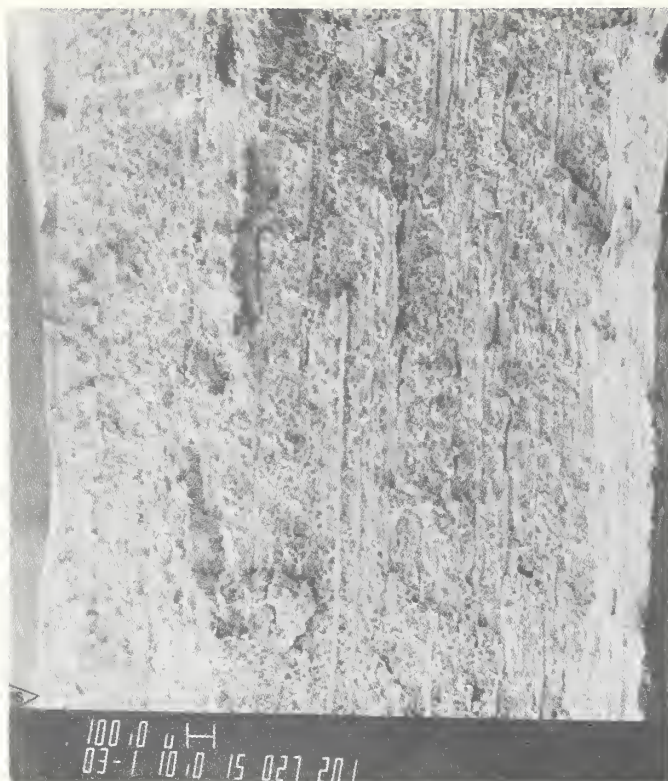
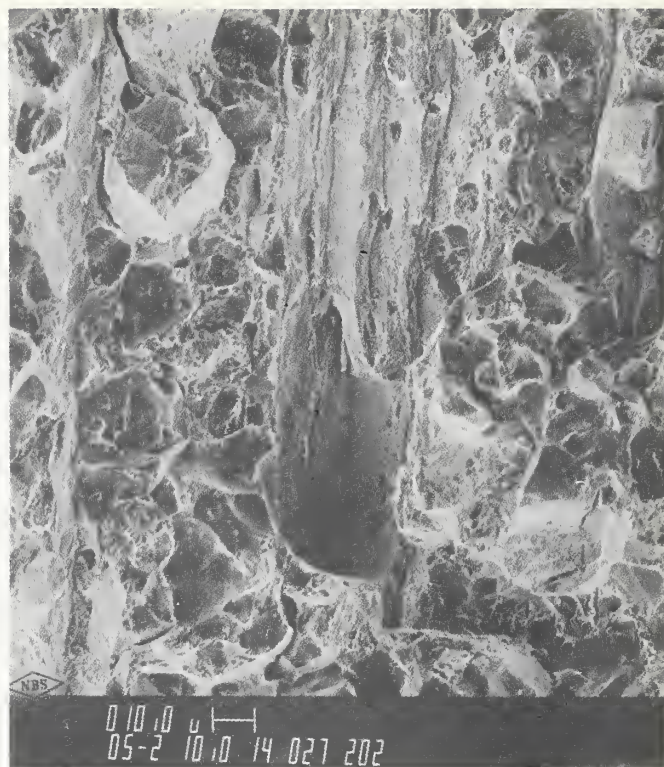
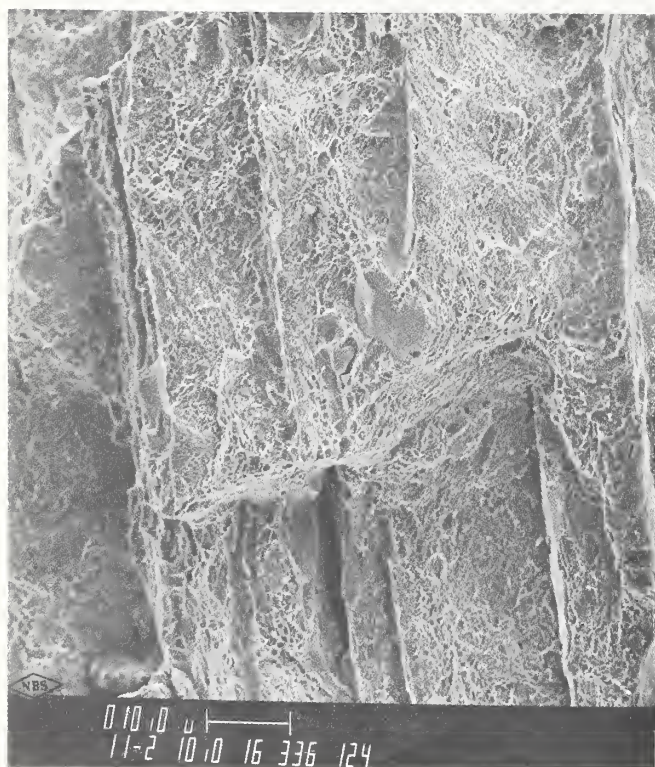
Figure 8.11 Fractographic appearance of hardened washer fractured in NBS test of walkway box beam 9M, washer installed at location 9MW (a). Center portion, area (b), reveals a mixture of brittle (intergranular and cleavage) and ductile fracture. Area (c) reveals ductile rupture through a decarburized surface layer. Elongated features are indicative of MnS stringers. Magnifications (a) X35, (b) X550, (c) X1050.

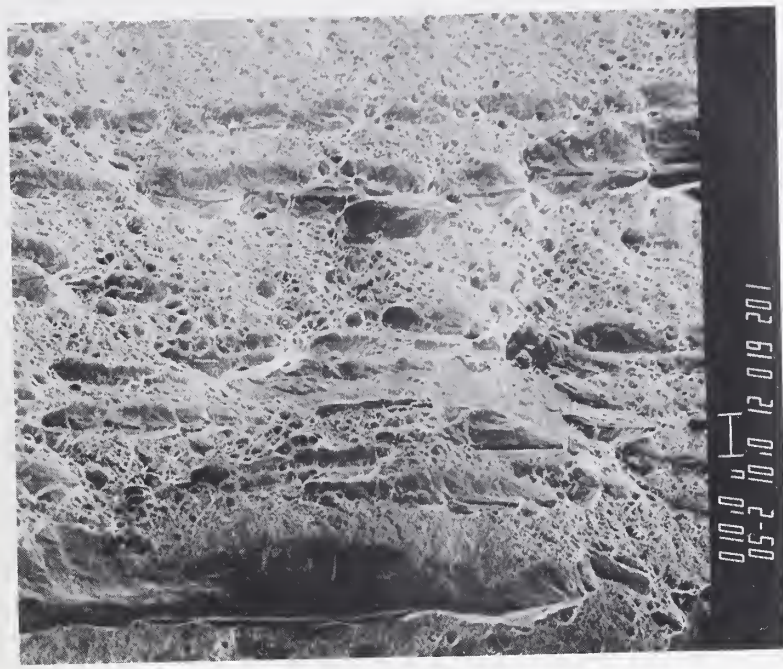
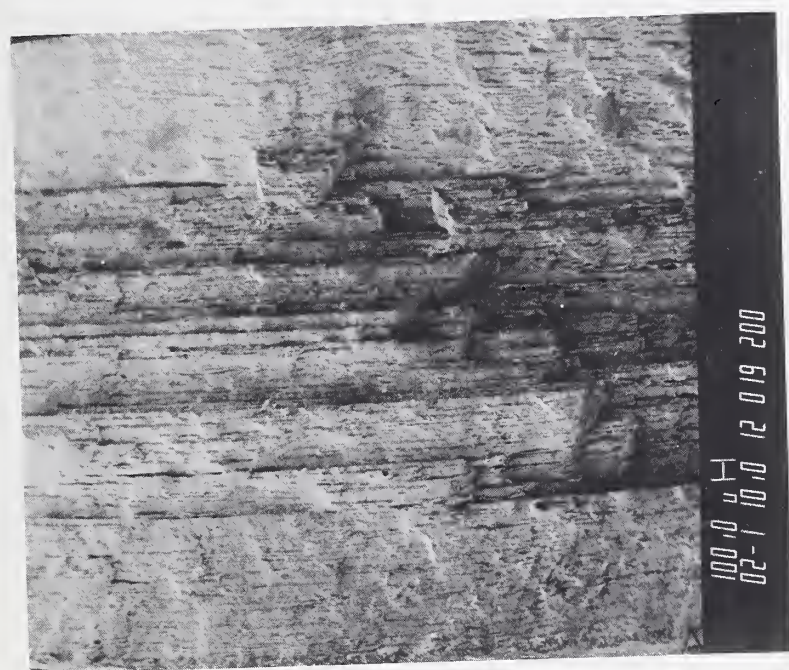
Figure 8.12 Fractographic appearance of walkway washer fractured in NBS test of box beam 9M (specimen KCl). Lower magnification view (a) shows high density of MnS stringers oriented parallel to the bend axis. Higher magnification view of center portion (b) shows mostly ductile rupture. Magnification (a) X25, (b) X550.

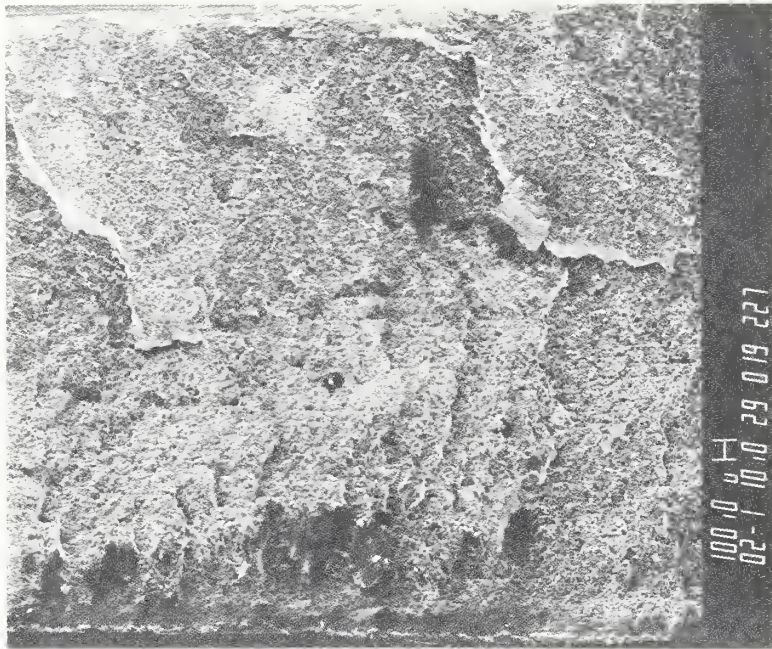
Figure 8.13 Fractographic appearance of walkway washer from upper end of hanger rod at location 9UE (NBS 11B) broken at NBS. Lower magnification view (a) shows no prominent MnS inclusions. Higher magnification view of center portion (b) shows essentially brittle intergranular fracture with a small amount of ductile rupture. Magnification (a) X25, (b) X550.

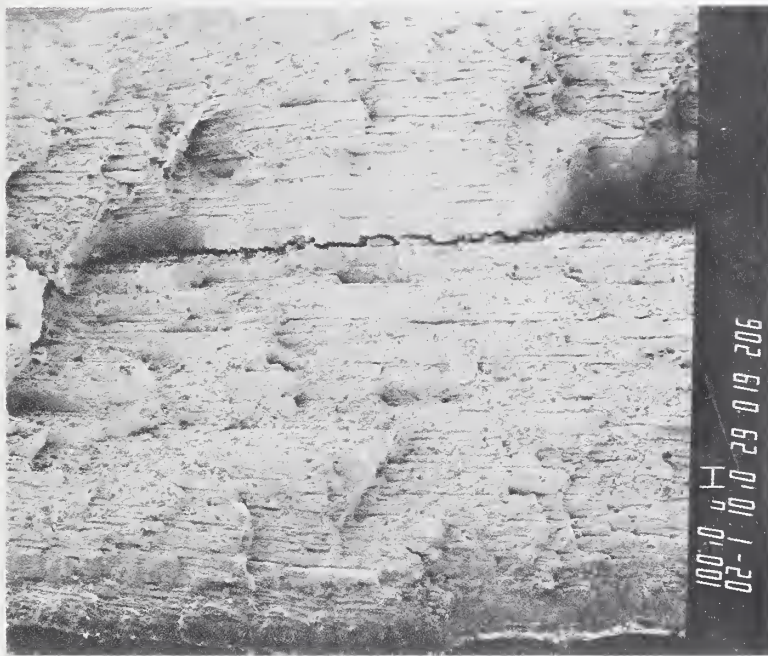
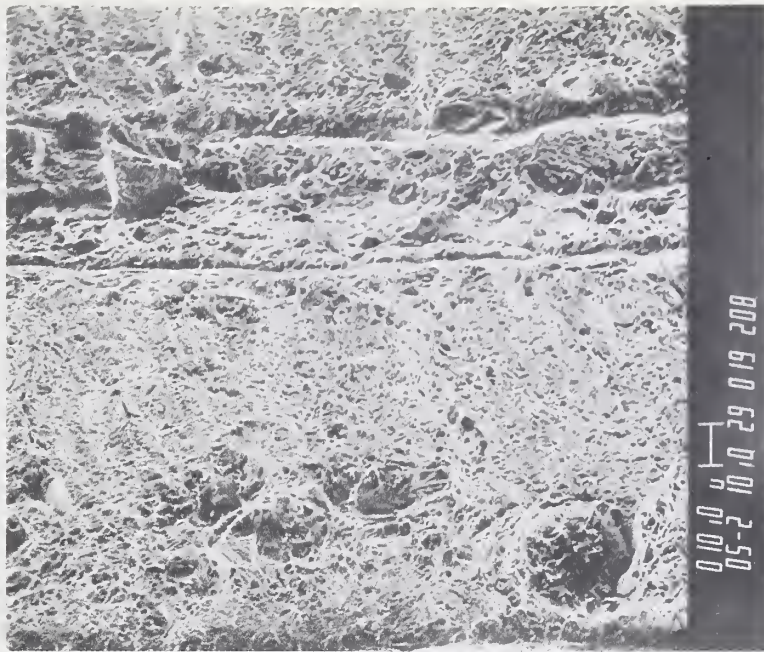
Figure 8.14 Fractographic appearance of NBS washer No. 3 broken at NBS. Low magnification view (a) shows elongated MnS inclusions. Higher magnification view of center portion (b) shows essentially ductile rupture. Magnification (a) X25, (b) X550.

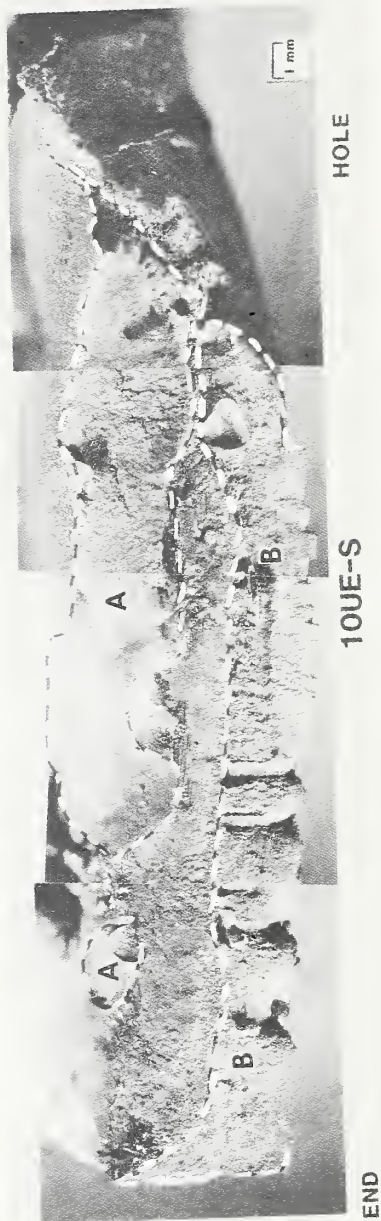
Figure 8.19 One half of box beam lower fracture surface between beam end and outer hanger rod hole.

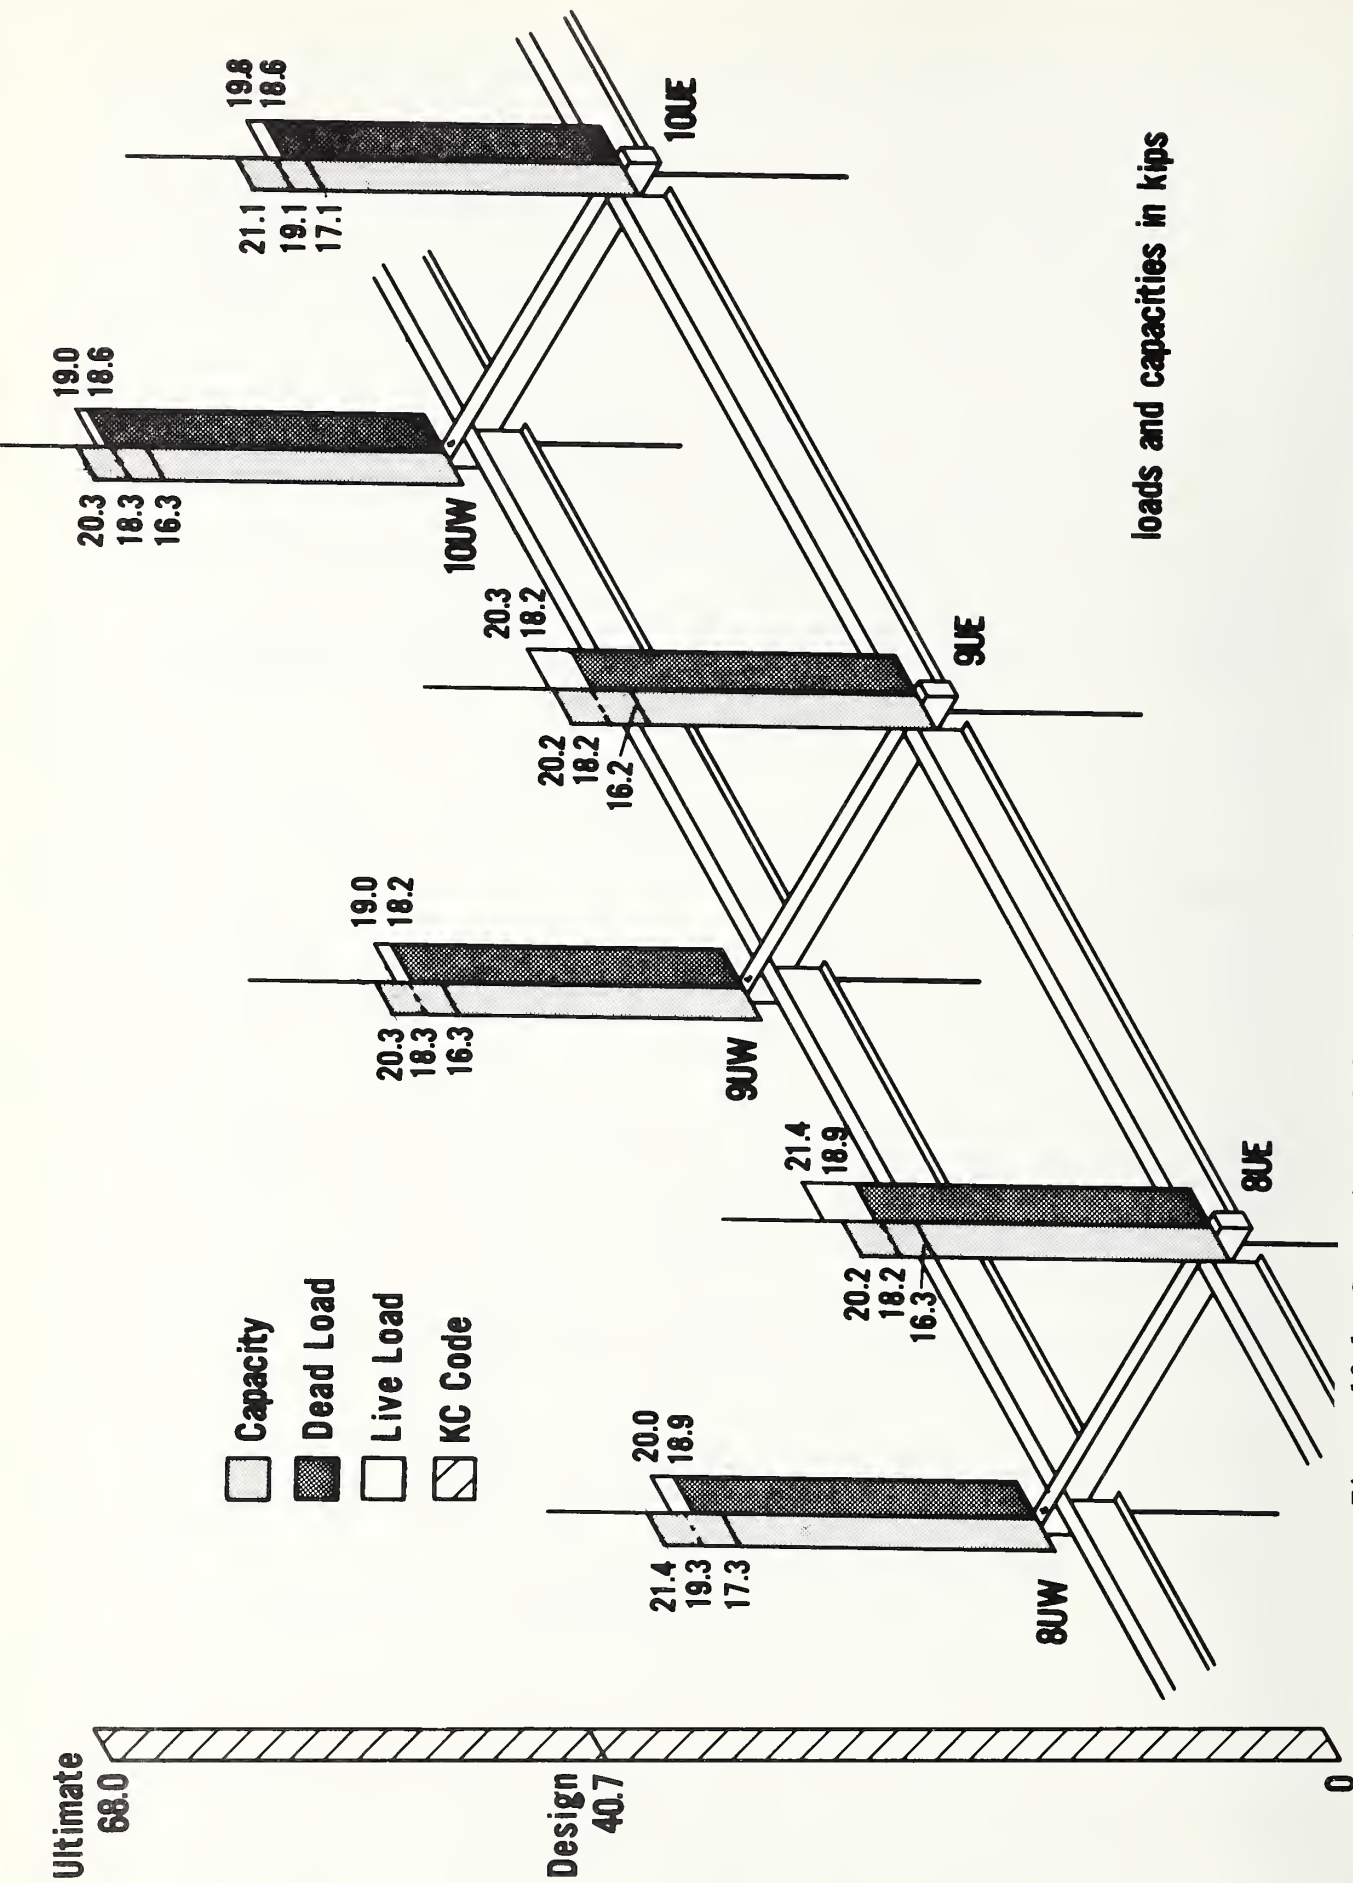
Figure 10.1 presents similar information for the other fourth floor box beam-hanger rod connections. This figure shows that, with the exception of locations 8UE and 10UW, the estimated mean ultimate capacity of each fourth floor box beam-hanger rod connection either equals or slightly exceeds the estimated dead load effect. However, the estimated mean ultimate capacity is exceeded by the sum of the estimated dead load and upper-bound live load in every case.

Figure 10.1 Comparison of fourth floor walkway box beam-hanger rod connection capacities with loads believed to have been acting at time of collapse.

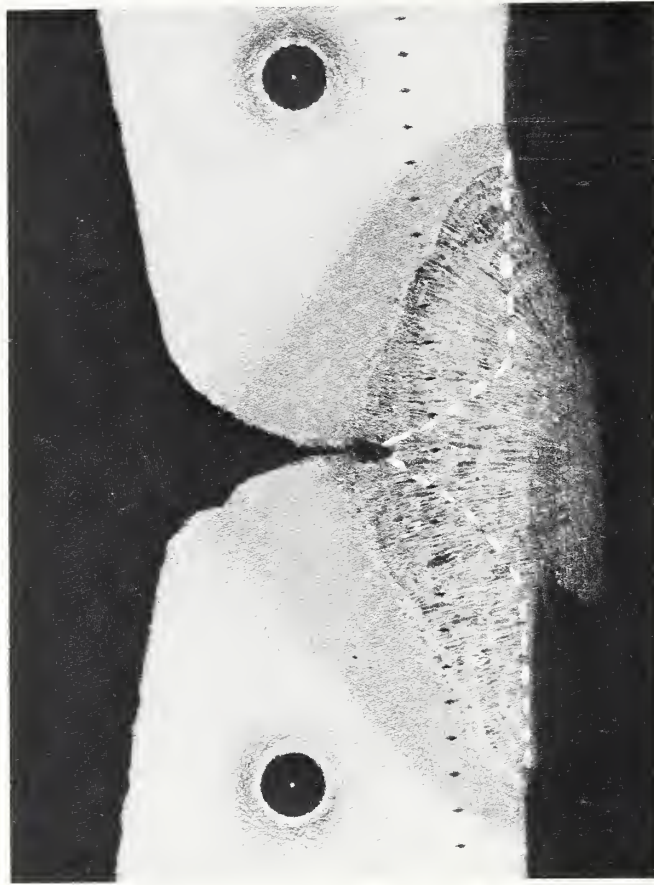
11. Average joint penetration for the box beam longitudinal welds was less than that required by AWS D1.1-79 for a prequalified partial joint penetration groove weld. However, it is concluded that due to the presence of tack welds the actual ultimate capacities of the box beam-hanger rod connections probably were higher than would be expected for a partial joint penetration groove weld with the prescribed minimum effective throat acting alone.

Figure 10.3 Cross section through weld region of walkway box beam 8L showing the exterior longitudinal weld joint at the bottom flange. Dotted lines indicate approximate original geometry of the flange toes. X8 1/2

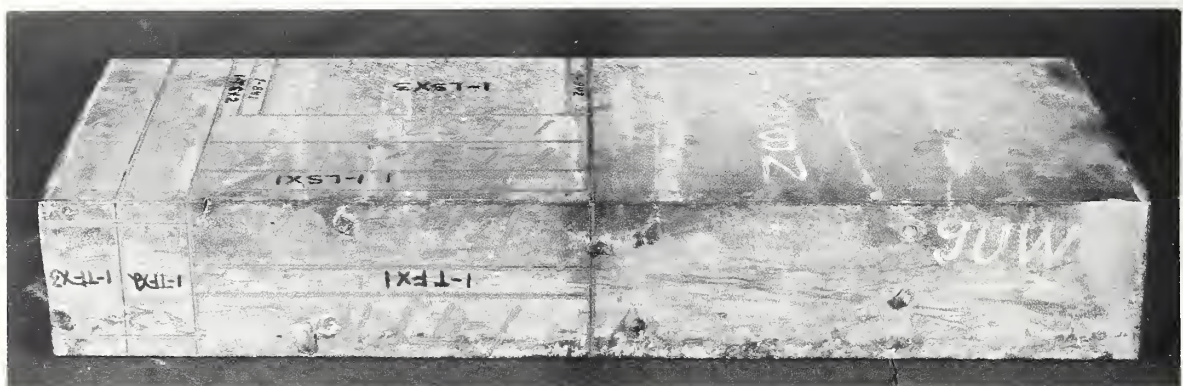
Figure A7.3.2-1

d. Top of box beam segment 9U (NBS 1).

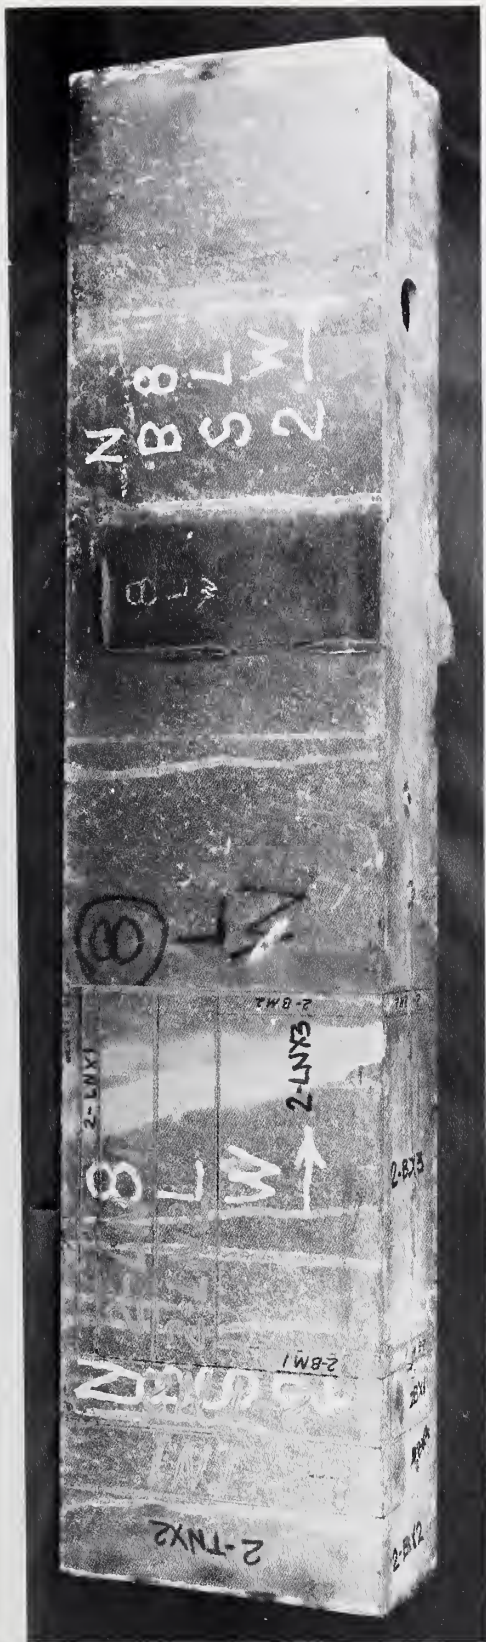
a. North face of box beam segment 8L (NBS 2).

Figure A7.3.2-2 Location of test specimens from box beam segment 8L obtained from the walkway debris.

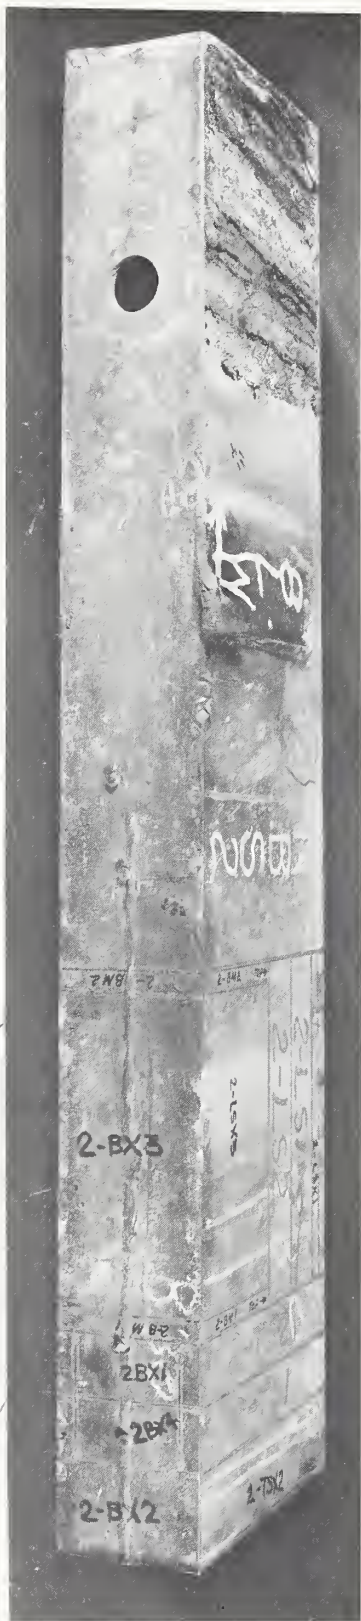
b. Bottom of box beam segment 8L (NBS 2).

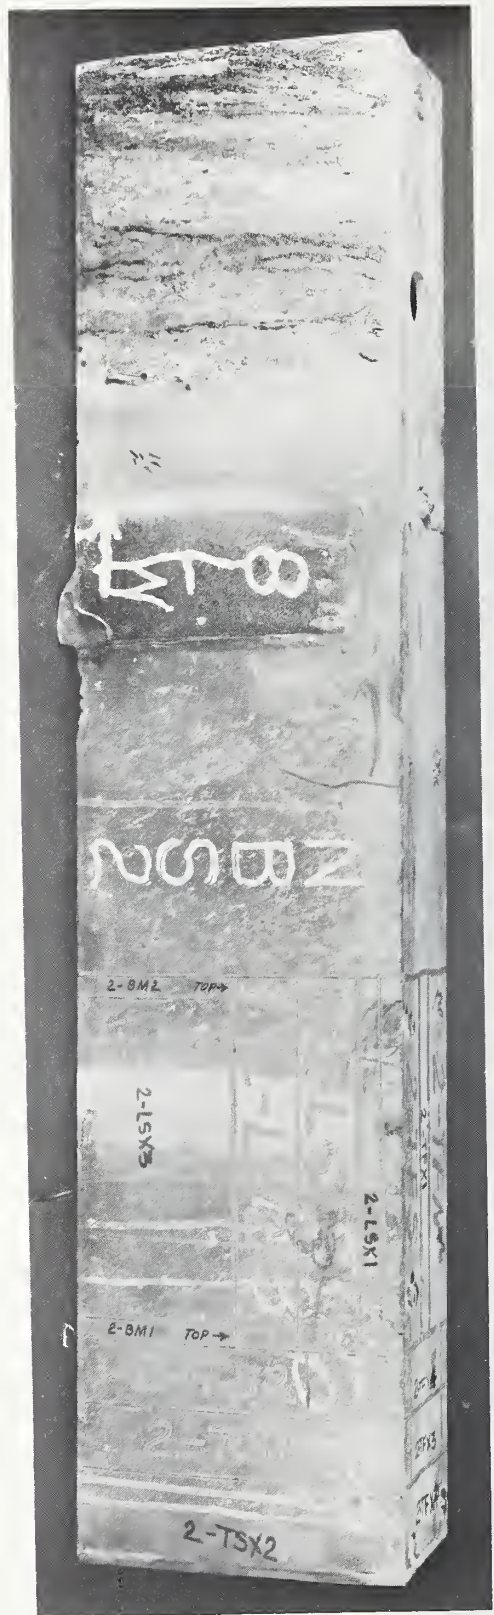
Figure A7.3.2-2

c. South face of box beam segment 8L (NBS 2).

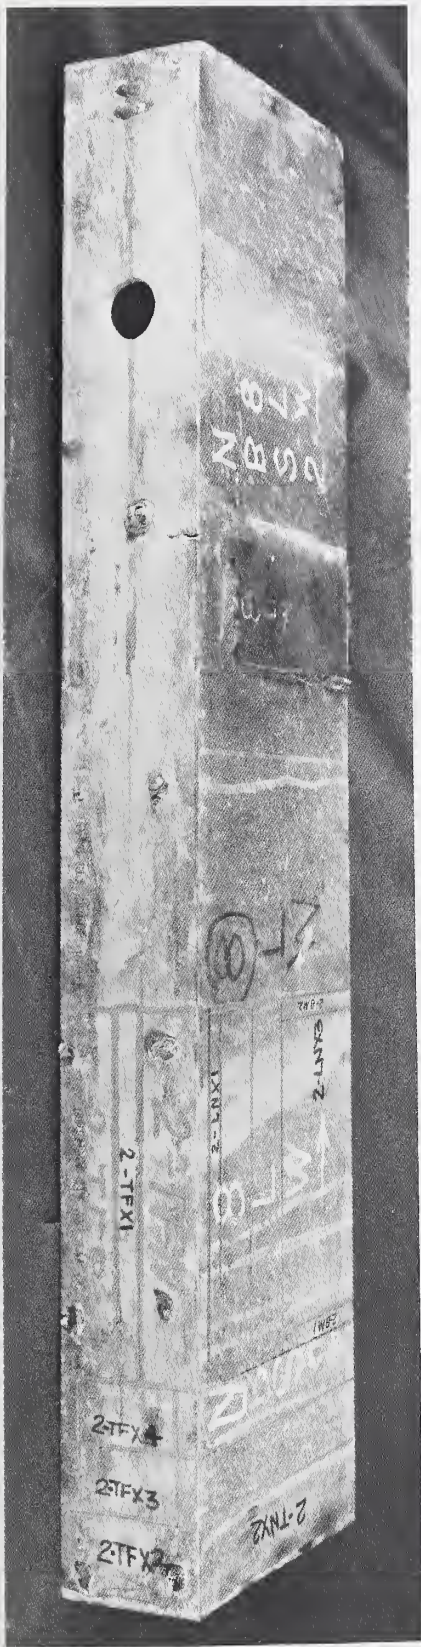
d. Top of box beam segment 8L (NBS 2).

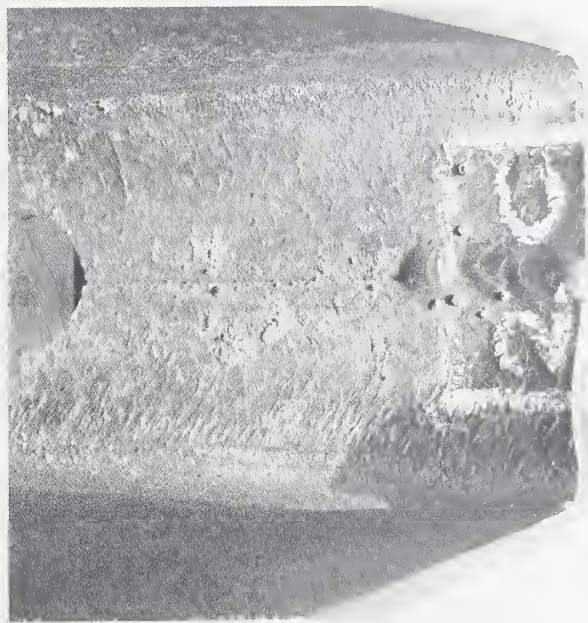
Figure A7.3.2-2

e. Bottom interior of box beam segment 8L (NBS 2).

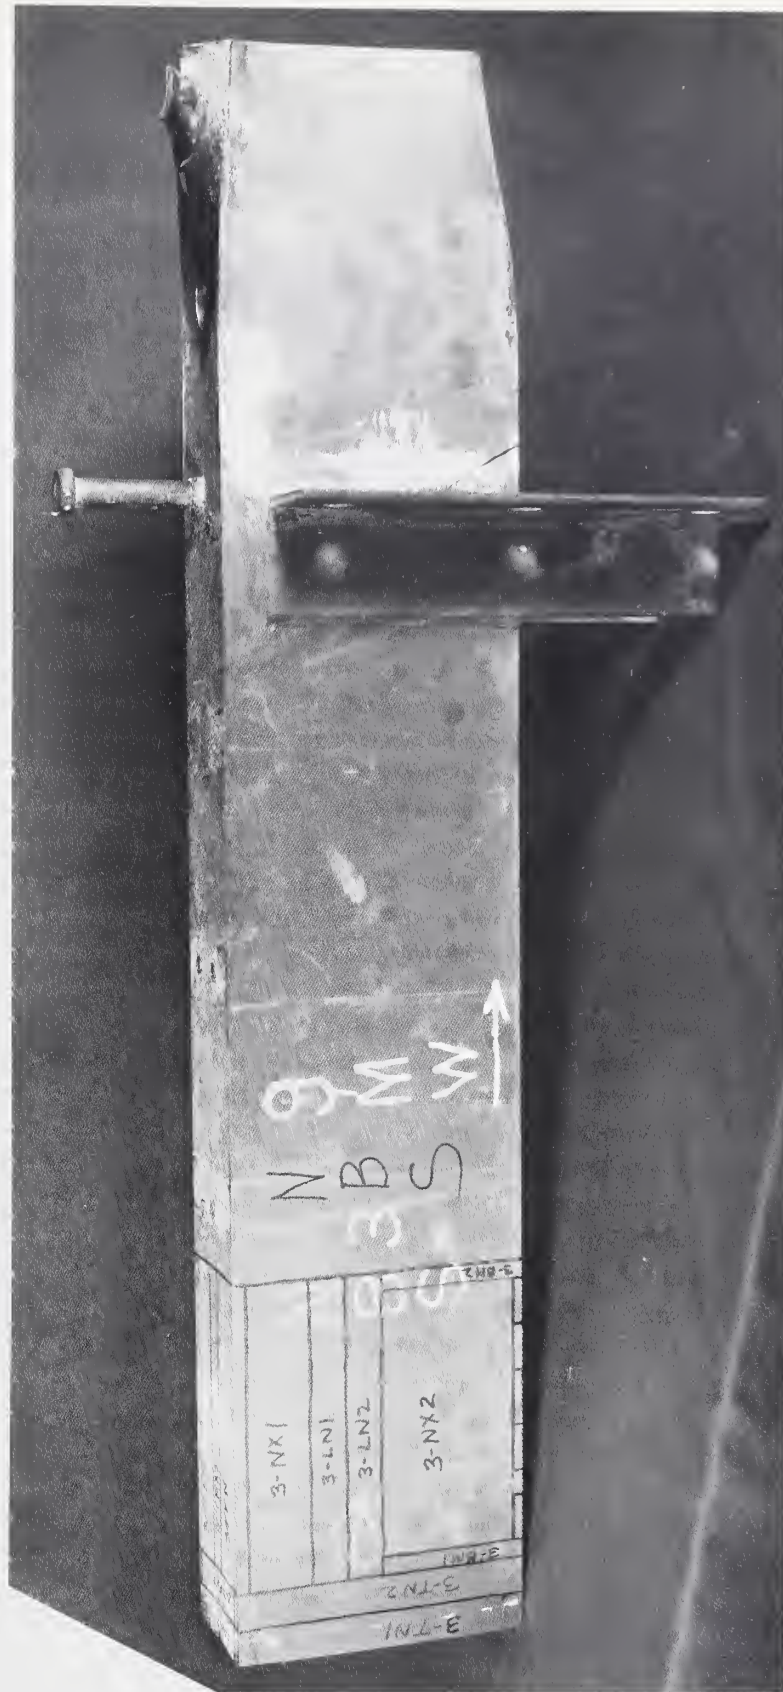
Figure A7.3.2-3 Location of test specimens from box beam segment NBS 3-5 from box beam 9M obtained from the walkway debris.

a. North face of box beam segment 9M (NBS 3-5).

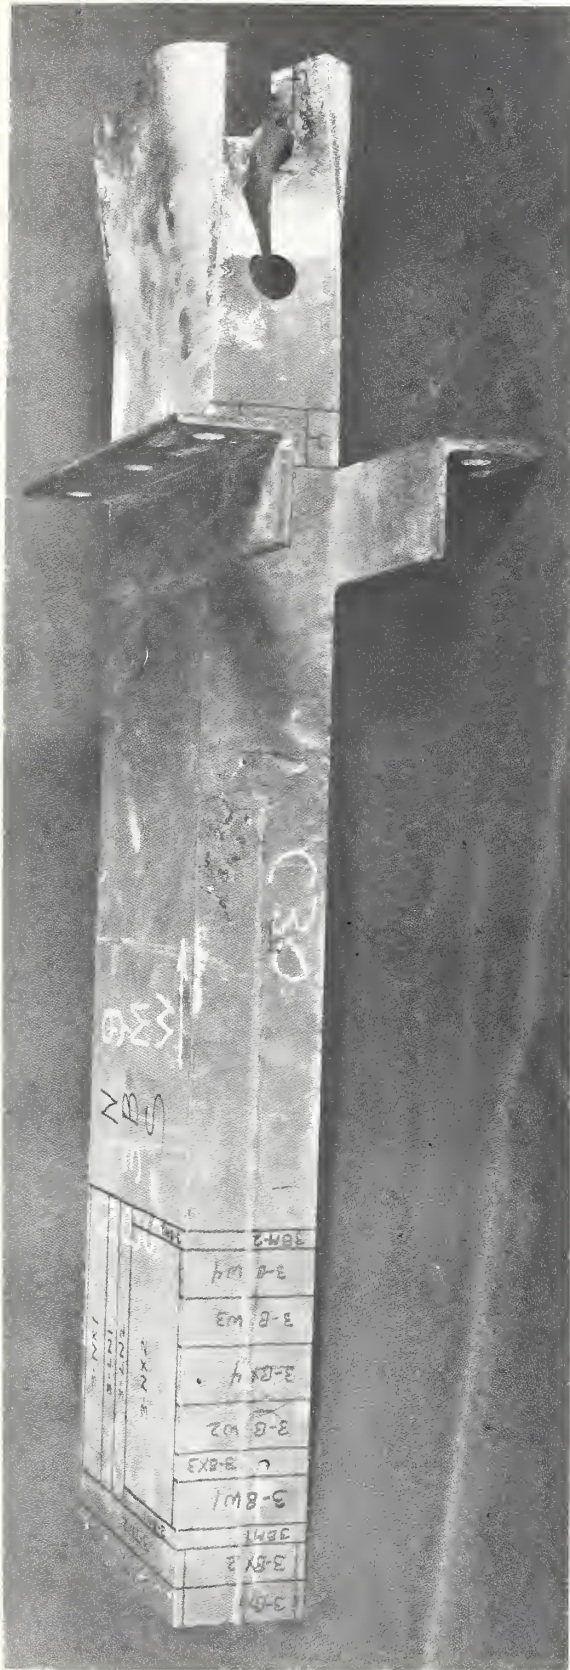
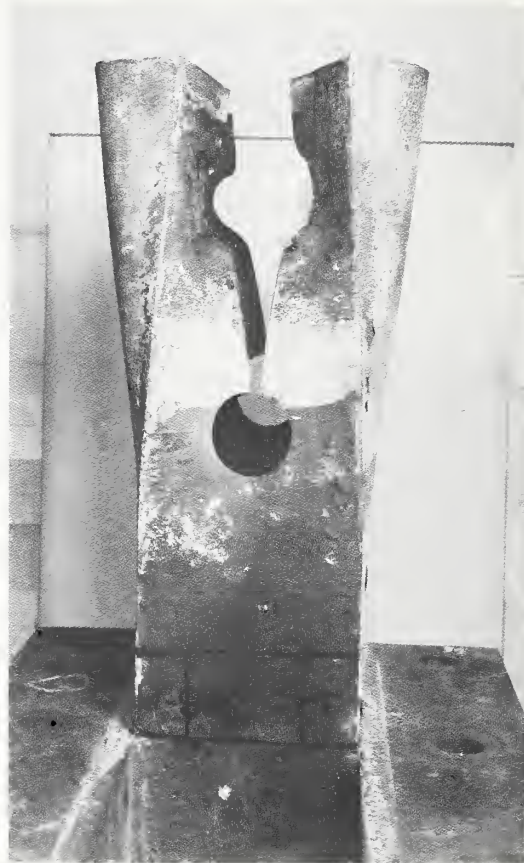
Figure A7.3.2-3

b. Bottom of box beam segment 9M (NBS 3-5).

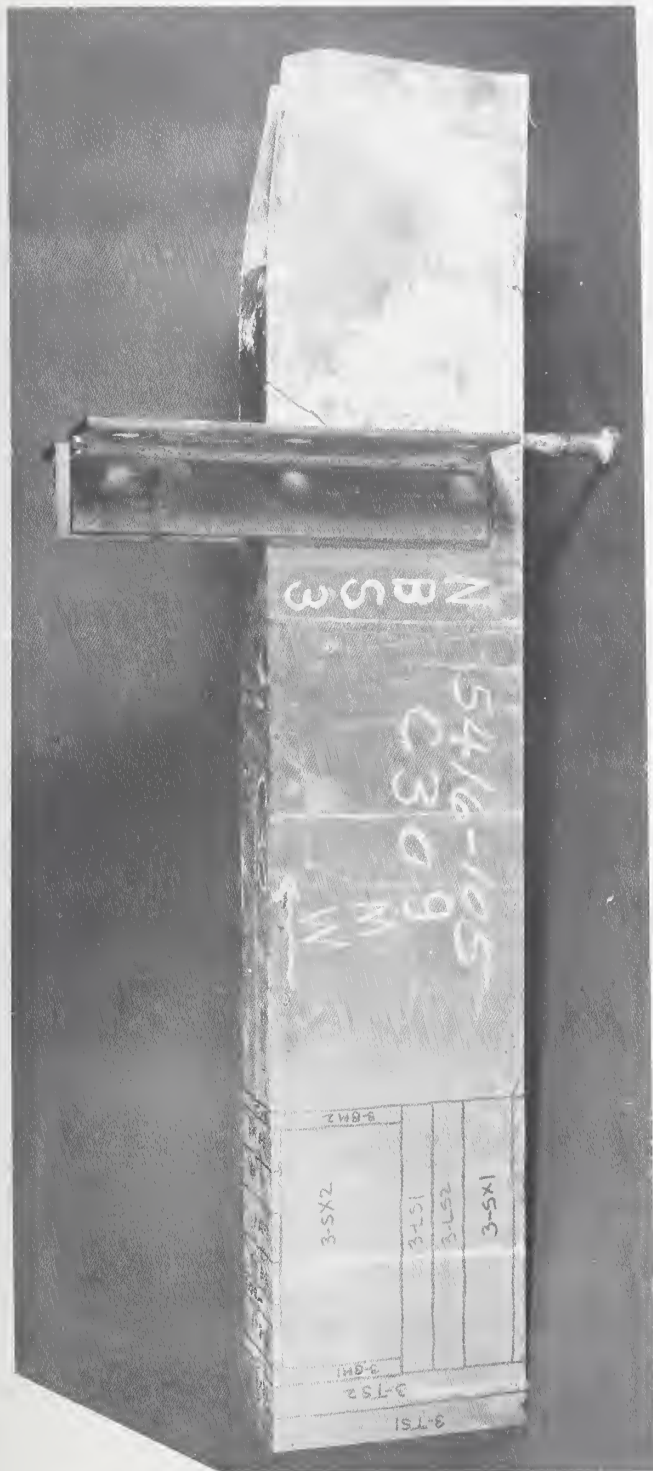
c. South face of box beam segment 9M (NBS 3-5).

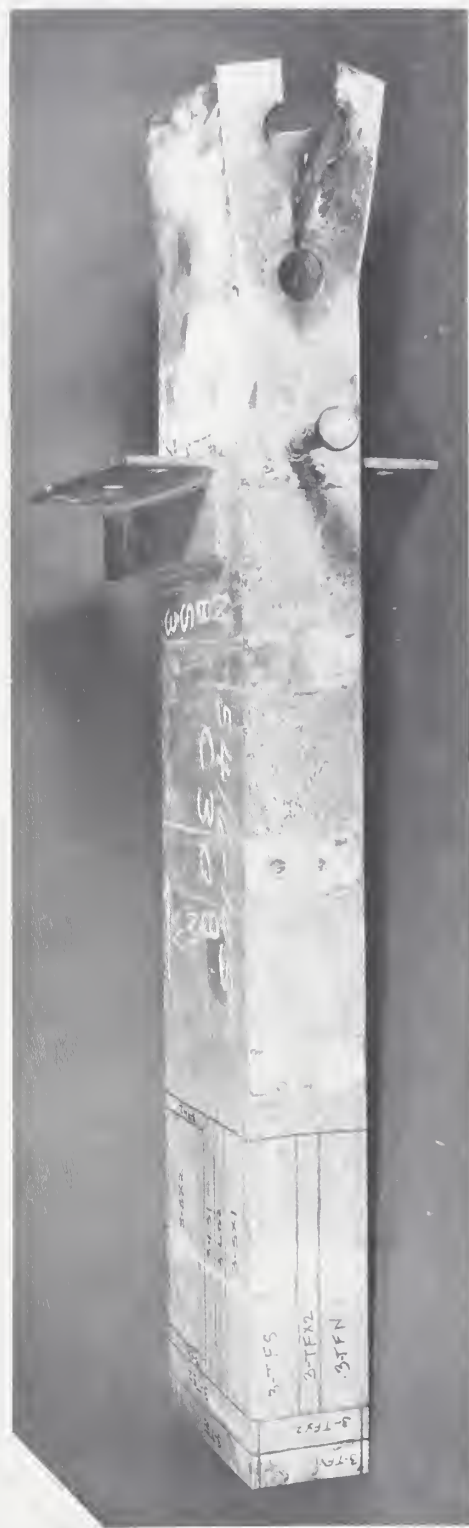
Figure A7.3.2-3

d. Top of box beam segment 9M (NBS 3-5).

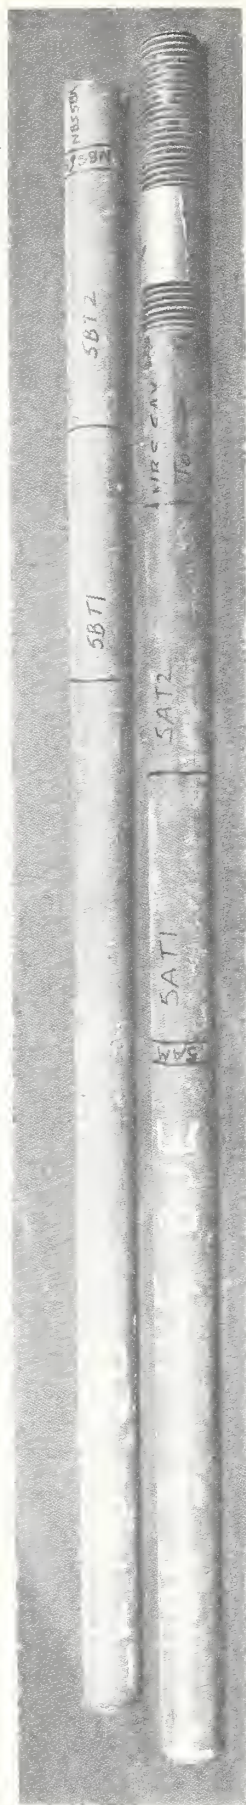
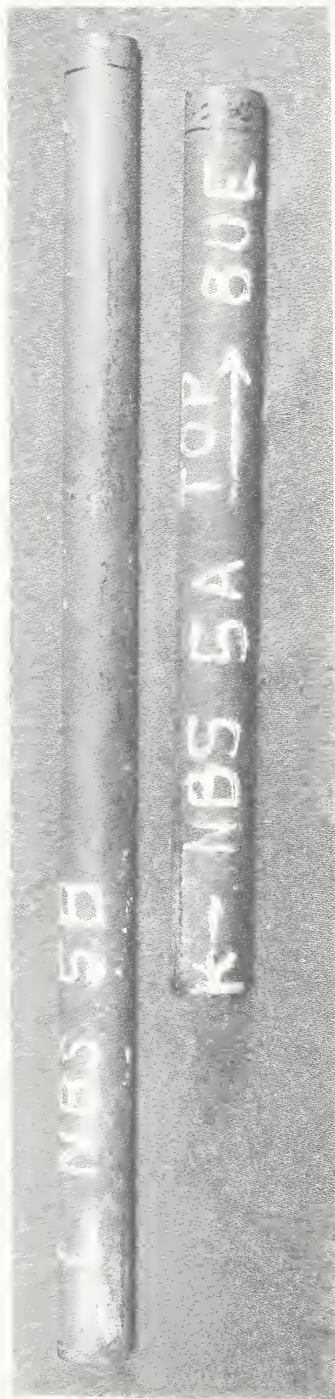
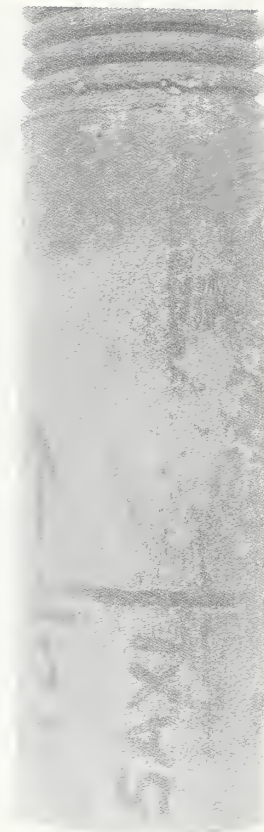
Figure A7.3.3-1. Location of test specimens from hanger rod segments NBS 5A and NBS 5B obtained from the walkway debris.

Longitudinal tensile test specimens 5AT1, 5AT2, 5BT1, 5BT2
 Metallographic specimens 5AM, 5BM
 Chemical analysis specimens 5AC, 5BC, 5AX1, NBS 5BX

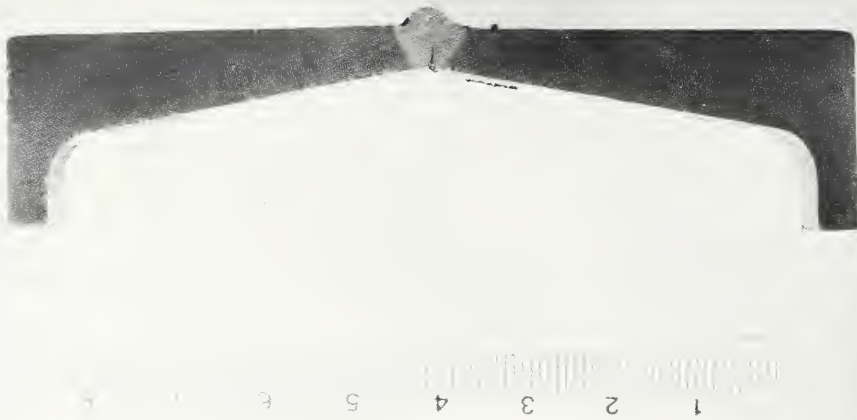
Figure A7.4.1-1 Transverse section through NBS weldment IC welded by the GMAW process using mild steel welding rod. The weld is in the center connecting flange parts of the two channel segments. Parts of the web regions of each channel are also included in the section. Etchant: two percent nital ~X1

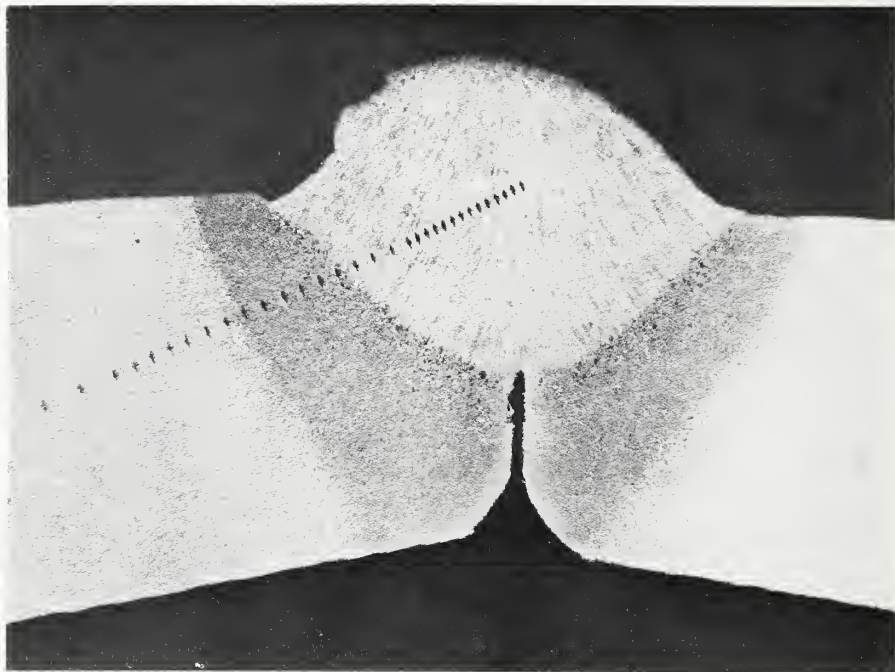
Figure A7.4.1-2. Part of the transverse section shown above, but a higher magnification. The light region in the center is weld metal. The dark regions adjacent to the weld metal are the heat affected zones. The light regions to the left and right in the photograph represent base flange regions of the channel segments. The line of small dark, elongated marks is the result of microhardness measurements. Etchant: two percent nital. X8.5

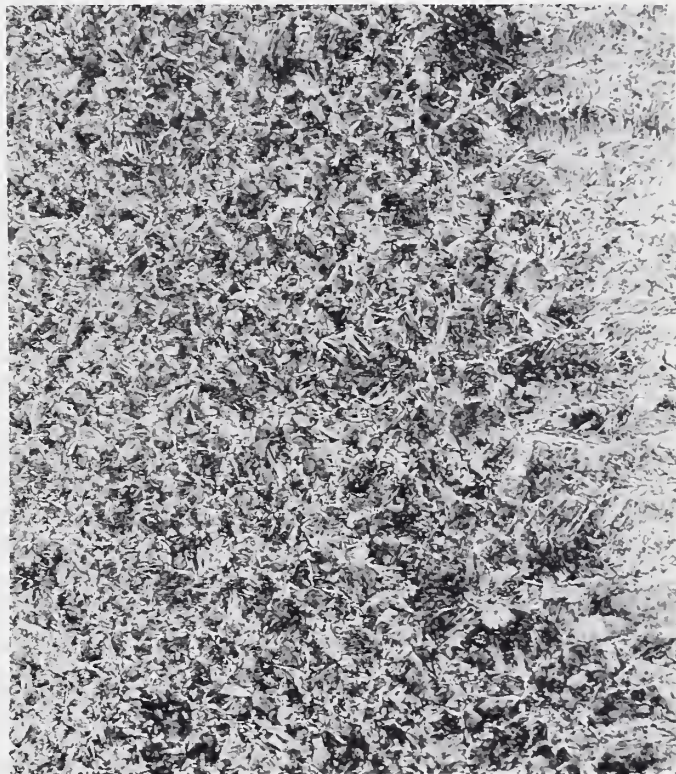
Figure A7.4.1-4 Transition region from weld metal (right) to heat affected zone (left) in transverse section through NBS weldment IC. Etchant: two percent nital. X200

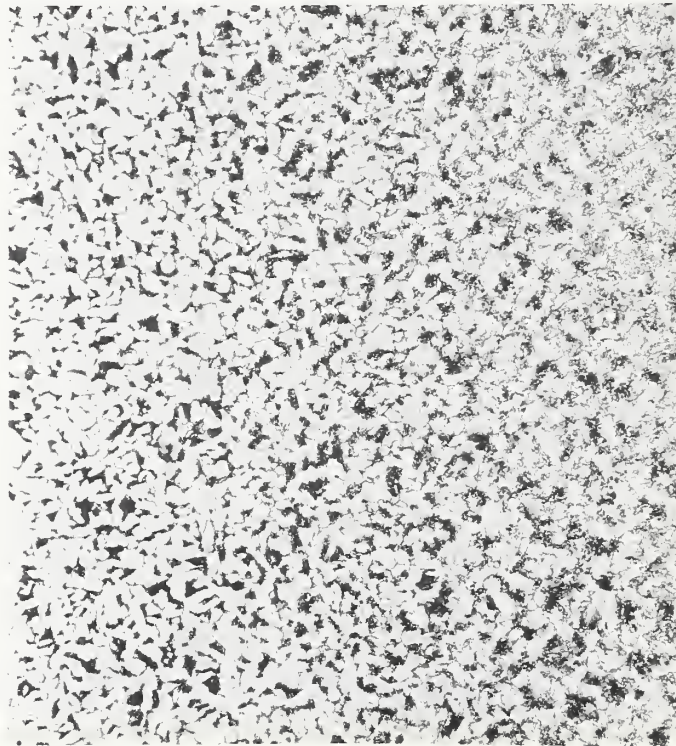
Figure A7.4.1-6 Microstructure representative of the transition region from the heat affected zone (right) to base channel material (left) in NBS weldment IC. Etchant: two percent nital. X200

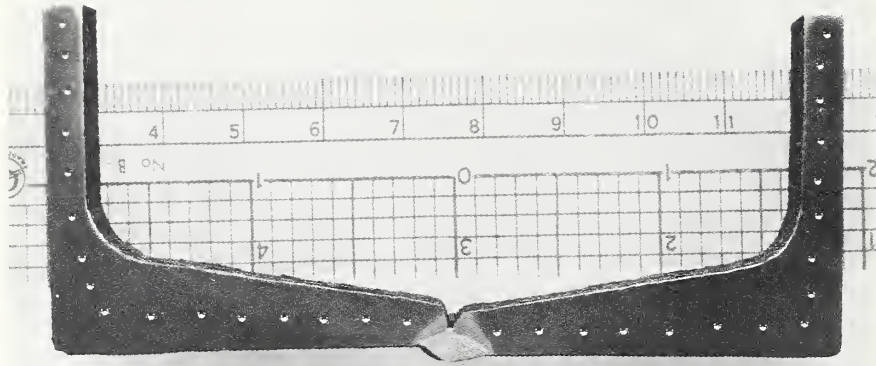
Figure A7.4.1-8 Transverse section 1BM1 through the bottom of walkway box beam 9U (NBS 1). The north channel of the box beam is to the left and the south channel is to the right. The weld connecting the flanges of the two channels used to fabricate the box beam is in the center. Parts of the web regions of each channel had been removed before this photograph was taken. The indentations appearing on the surface of the section are the result of hardness measurements. Etchant: two percent nital. ~X1

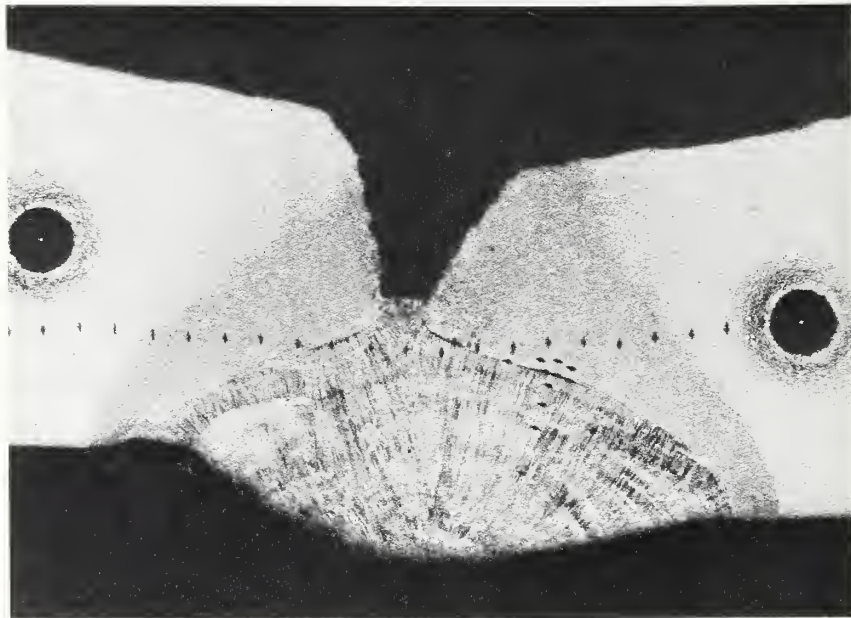
Figure A7.4.1-9 Part of the transverse section shown in figure A7.4.1-8, but at higher magnification. The region at the bottom center is weld metal. The dark gray regions on either side of the weld metal are the heat affected zones associated with the weld. The lighter regions at either side of the figure beyond the heat affected zone are base channel material. Etchant: two percent nital. X8.5

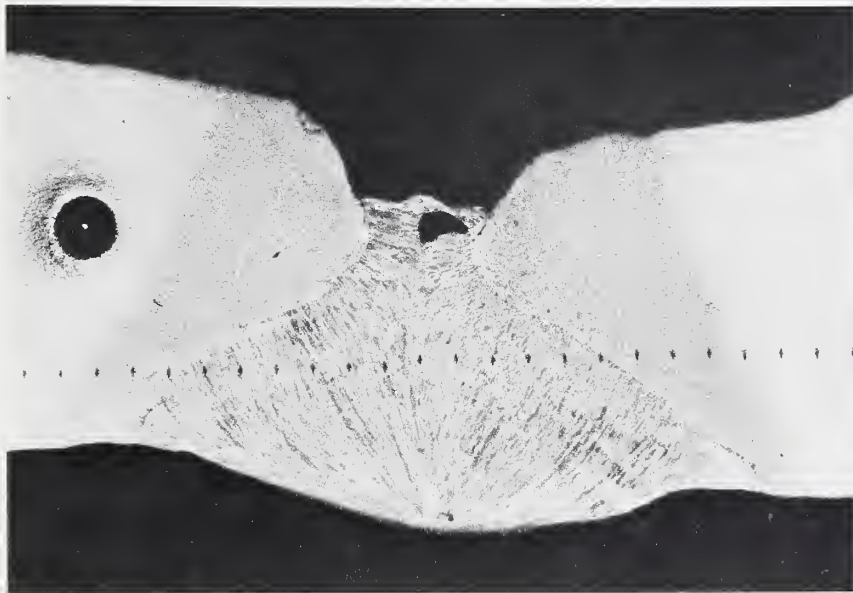
Figure A7.4.1-11 Part of the transverse section shown in figure A7.4.1-10, but at higher magnification. The region at the bottom center is weld metal. The dark gray regions on either side of the weld metal are the heat affected zones associated with the weld. The lighter regions on either side of the photomicrograph are base channel material. Etchant: two percent nital. X8.5

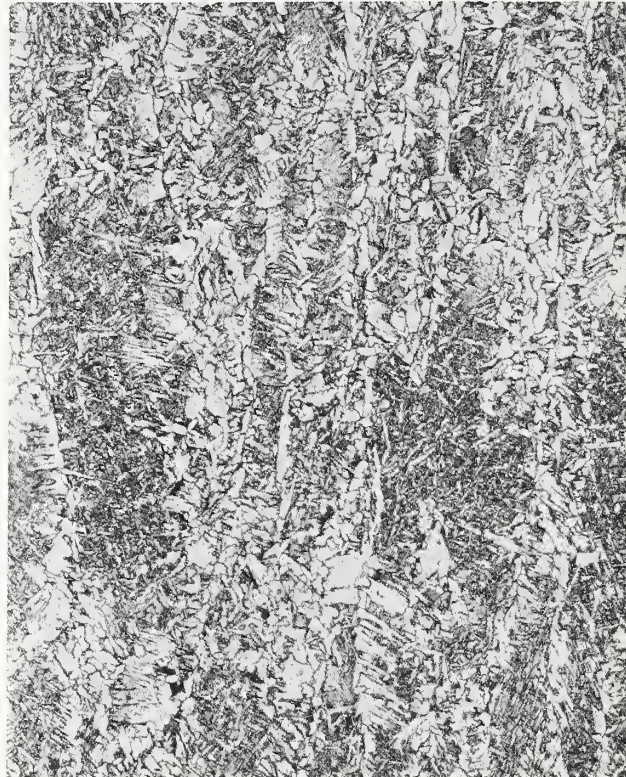
Figure A7.4.1-13 Representative microstructure of the weld metal in transverse section 1BM2 through box beam 9U (NBS 1). The microstructure consists primarily of bainite. Etchant: two percent nital. X200

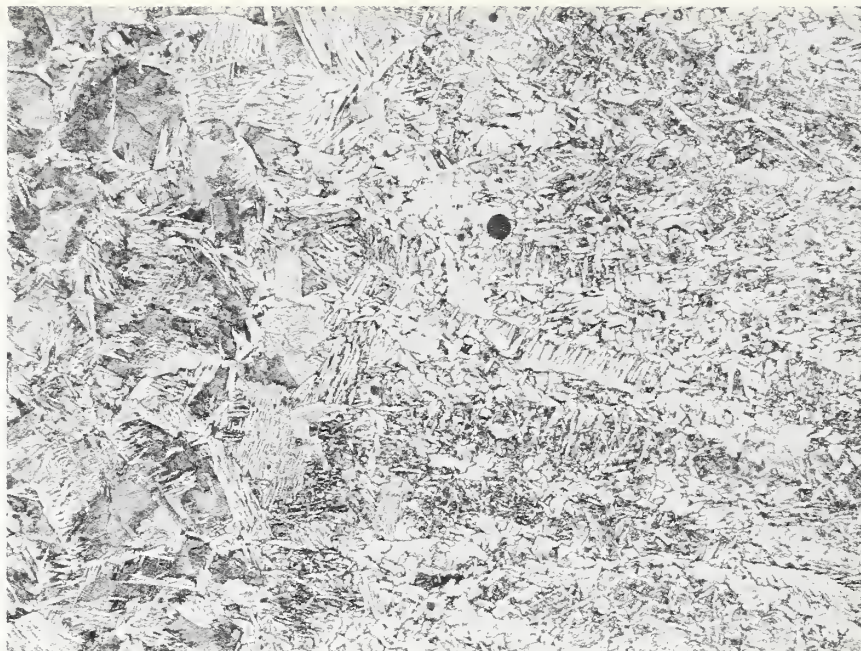
Figure 7.4.1-16 Transition zone from weld metal (right) to heat affected zone (left) in section 1BM2. Some inclusions can be seen. Etchant: two percent nital. X200
